hepburn wind community energy

Hybrid Planning Permit | Attachment 6

Geotechnical Investigation

Geotechnical Investigation – Hepburn Wind Solar Farm

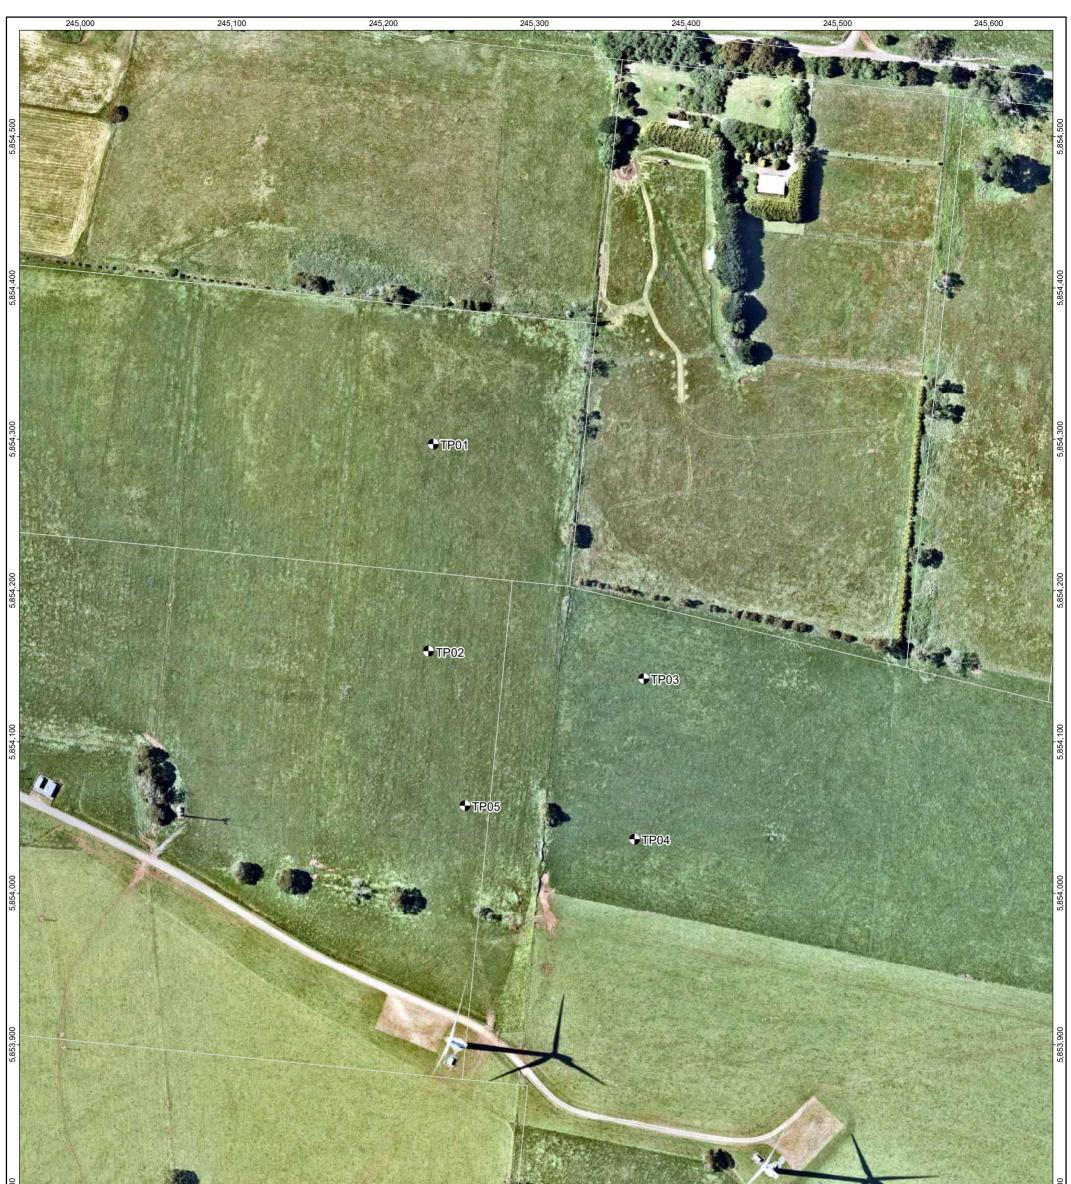
The fieldwork was undertaken on 5 February 2020 and comprised the completion of 5 test pits, designated TP01 to TP05, to 2m depth and Dynamic Cone Penetrometer (DCP) test adjacent to each test pit at various locations around the area of the proposed solar farm.

the test pits and prepared engineering logs. The test pit locations were recorded using a hand held GPS unit and the coordinates are presented on the engineering logs.

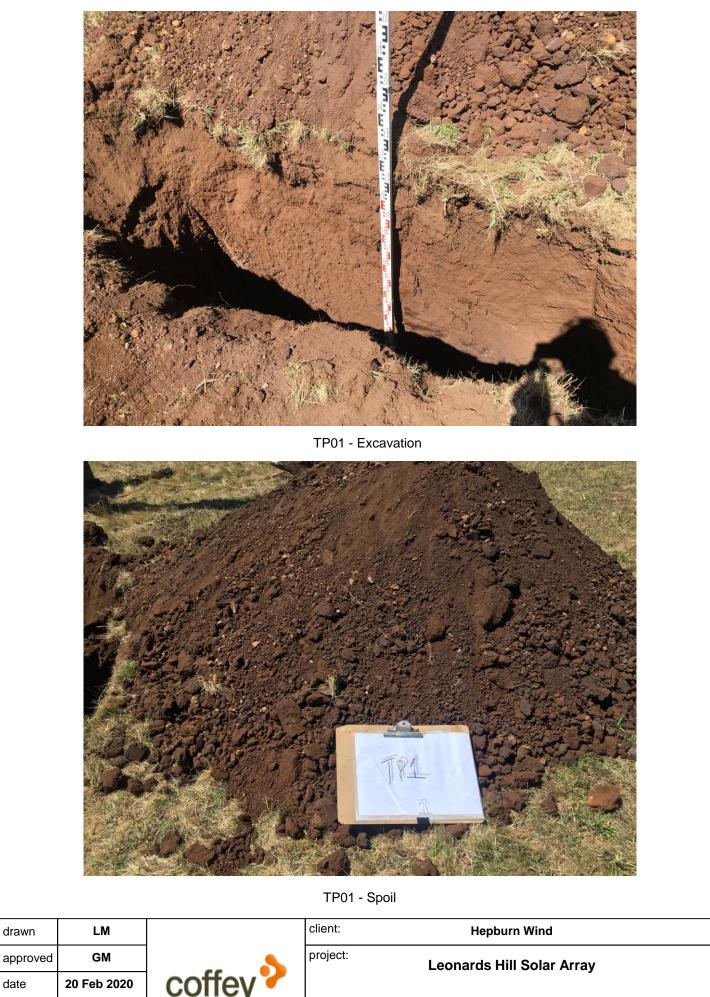
figure no:	TP01
--	------------	------

$\begin{array}{c c c c c c c c c c c c c c c c c c c $			6	s CH	CLAY: medium to high plasticity, dark brown, rootlets top 300 mm.	D	vst H			NATURAL HP 300 - 340 kPa; VS 65 kPa

- - 2.5 - - 3.0 - - - - - - - - - - - - - - - - - -			Test pit TP01 terminated at 2.2 m Target depth					
meth AD AS HA W * e.g. B T V	AD auger drilling* M AS auger screwing* C HA hand auger W washbore Pen * bit shown by suffix e.g. AD/T B blank bit T TC bit			leve		l ater shown	samples & field tests B bulk disturbed sample D disturbed sample E environmental sample SS split spoon sample U## undisturbed sample ##mm diameter HP hand penetrometer (kPa) N standard penetration test (SPT) N* SPT - sample recovered Nc SPT with solid cone VS vane shear; peak/remouded (kPa) R refusal HB hammer bouncing	base moistur D dr M m W w Wp pl	d on AS	1726:2017 ion	V S F S V H F V L M D	firm st stiff 'St very stiff b hard b friable 'L very loose loose 1D medium dense

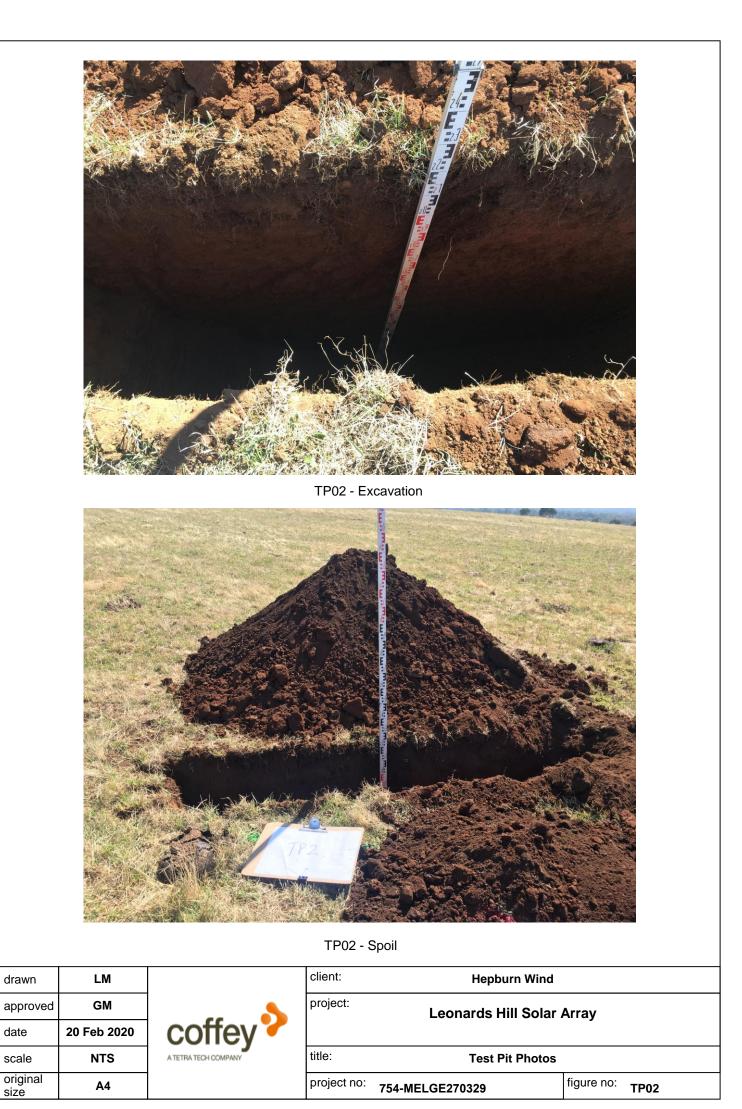
∞ ≤ 		Ľ	-	6	ML	Clayey SILT: low liquid limit, brown, trace clay.	D	St			NATURAL HP 140 - 170 kPa; VS 68 kPa
	Not Observed			0.5 — - - - 1.0 —		 ML	Clayey SILT: medium liquid limit, brown, with silt, trace sand.		VSt - H			HP 550 kPa; VS 153 kPa
		D		- - - 1.5 - - -

2.0			Test pit TP02 terminated at 2.0 m Target depth					
				- - 3.0 - -								
	 			3.5 —

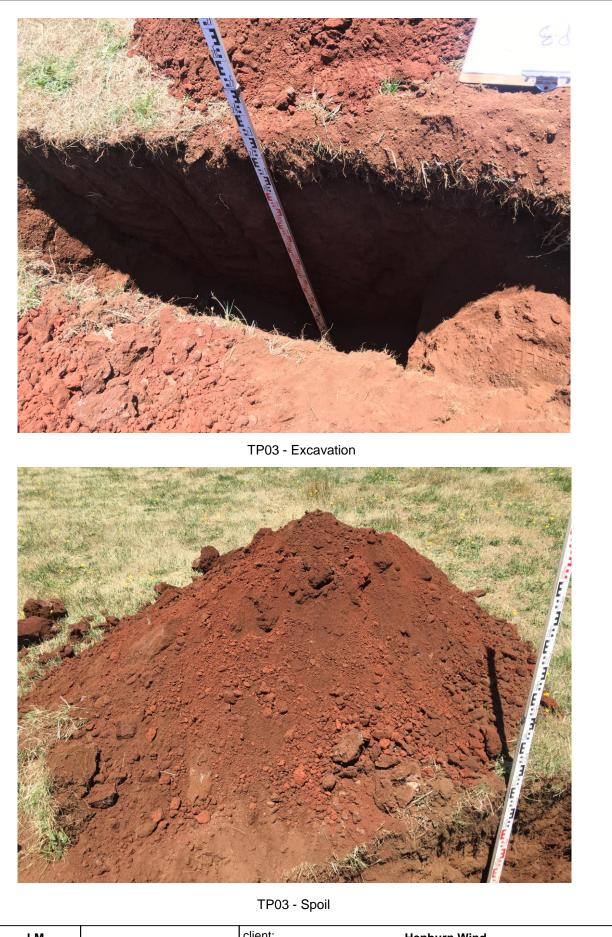
drawn	LM		client:	Hepburn Wind	
approved	GM		project:	Leonards Hill Solar	Array
date	20 Feb 2020	coffey			
scale	NTS	A TETRA TECH COMPANY	title:	Test Pit Photos	
original size	A4		project no:	754-MELGE270329	figure no: TP03

D		- - - 0.5—		ML	Clayey SILT: low to medium liquid limit, brown, trace sand.	D	St			NATURAL 		
		Not Observed					СН	CLAY: high plasticity, brown.		St-VS	S ()) ()) ()) ()) ()) ()) ()) ()		HP 150 - 180 kPa HP 200 - 220 kPa 		
		N			- - 1.5 - - -			grained gravel

- 2.0— -			Test pit TP03 terminated at 2.2 m							
					- - 2.5-			Target depth					1		
					-								1		
					- 3.0 <i>—</i>										
					-

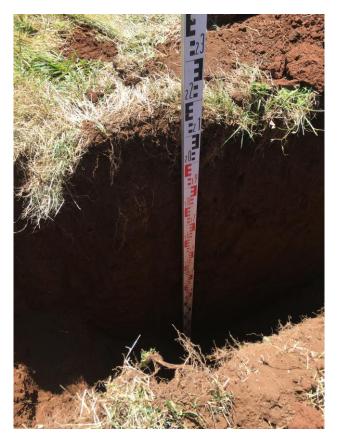
TP04 - Excavation

- - 0.5 - -								HP 350 - 450 kPa HP 600 kPa; VS 135 kPa
- BH		Not Observed	D	-	- 1.0 <i>-</i> -			trace highly weathered basalt gravel					VS 108 kPa

- H8				-	-			becoming brown-grey, high plasticity					HP 500 kPa
•					1.5— - - 2.0— -								
5					- 2.5			Test pit TP04 terminated at 2.2 m Target depth

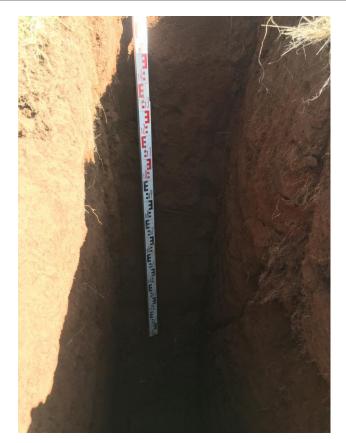
TP05 - Excavation

ATET				ANY							В	orehole l	D.	TP05
Ε	no	ıir	ne	erin	a l	_00	- k	Tes	st pit			neet:		
clie	-	_		oburn V	_		<u> </u>					oject no ate starte		754-MELGE270329 05 Feb 2020
	ncipa			oburn r								ate comp		05 Feb 2020
	ject:		Ιer	onards	Hills	Solar	Far	m		logged by:				FR
	ation			onards		Jonan	i un					necked b		LM
				4; N: 585405		A94)		surface elevation: Not Specified angle					al: 90°	DCP id.:
	drill model: CAse 580 SUper LE, Backhoe i						ounted		drilling fluid:		ole diam			
dri	drilling information						mate	rial sub			Ą	hand	DCD	ctmusture and
method &	Partial State Stat				depth (m)	graphic log	soil group symbol	material description SOIL NAME: plasticity or particle characteristic, colour, secondary and minor components	moisture condition	consistency / relative density	hand penetro- meter (kPa)	DCP (blows/ 100 mm)	structure and additional observations	
	E σ					5	 ML MH	Clayey SILT: low liquid limit, brown, trace fine to medium grained sand, rootlets top 200 mm.	D	VSt			NEWER VOLCANICS

Test pit TP05 terminated at 2.1 m Target depth					- - - - - - - - - - - - - - - - - - -
AD AS HA W	* bit shown by suffix e.g. AD/T B blank bit T TC bit				mud casing etration or ∞ er leve wate		il ater shown	samples & field tests B bulk disturbed sample D disturbed sample E environmental sample SS split spoon sample U## undisturbed sample ##mm diameter HP hand penetrometer (kPa) N standard penetration test (SPT) N* SPT - sample recovered Nc SPT with solid cone VS vane shear; peak/remouded (kPa) R refusal HB hammer bouncing	based moistur D dry M mo W we Wp pla	oil desci d on AS e conditi / bist	1726:2017 ion	C () () () () () () () () () (St stiff /St very stiff H hard Fb friable /L very loose
